Preliminary Report on the Performance of the New Orleans Levee Systems in Hurricane Katrina on August 29, 2005

Preliminary findings from field investigations and associated studies performed by teams from the University of California at Berkeley and the American Society of Civil Engineers, as well as a number of cooperating engineers and scientists, shortly after the hurricane.

Report No. UCB/CITRIS – 05/01
November 2, 2005

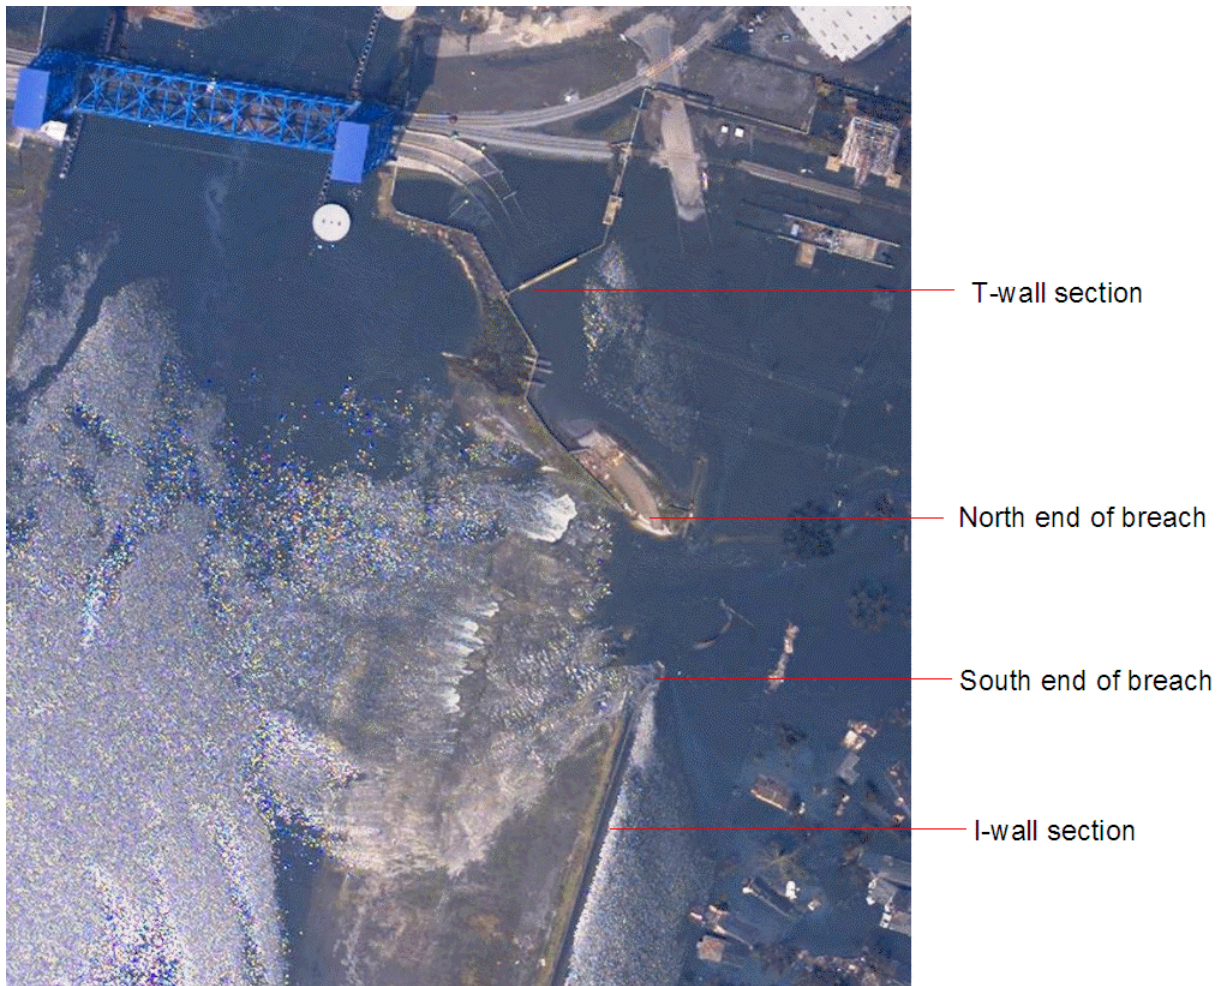
The unbreached portions of the I-wall system located immediately south of the failure were tilted inward (landward). The tilted I-walls reached their maximum inclination of approximately 3 degrees near the breach and gradually tapered to close to vertical at further distances. Scour trenches at the toe of the floodwall (protected side) were found along the entire length of the intact I-wall section. The scour trenches were typically about 5 feet wide at the top and extended to depths of approximately 3 to 4 feet. As with the south breach, the scour trenches were wide and u-shaped near the breached area and gradually became narrower, v-shaped and incised with distance from the breach. Scour was also noted along the land side of the T-wall levee sections (Fig. 4.8).

Fig. 4.8 - A scoured, but nevertheless well-performing "T-wall" levee section located near the north breach of the Lower Ninth Ward (J. Wartman, October 4, 2005).

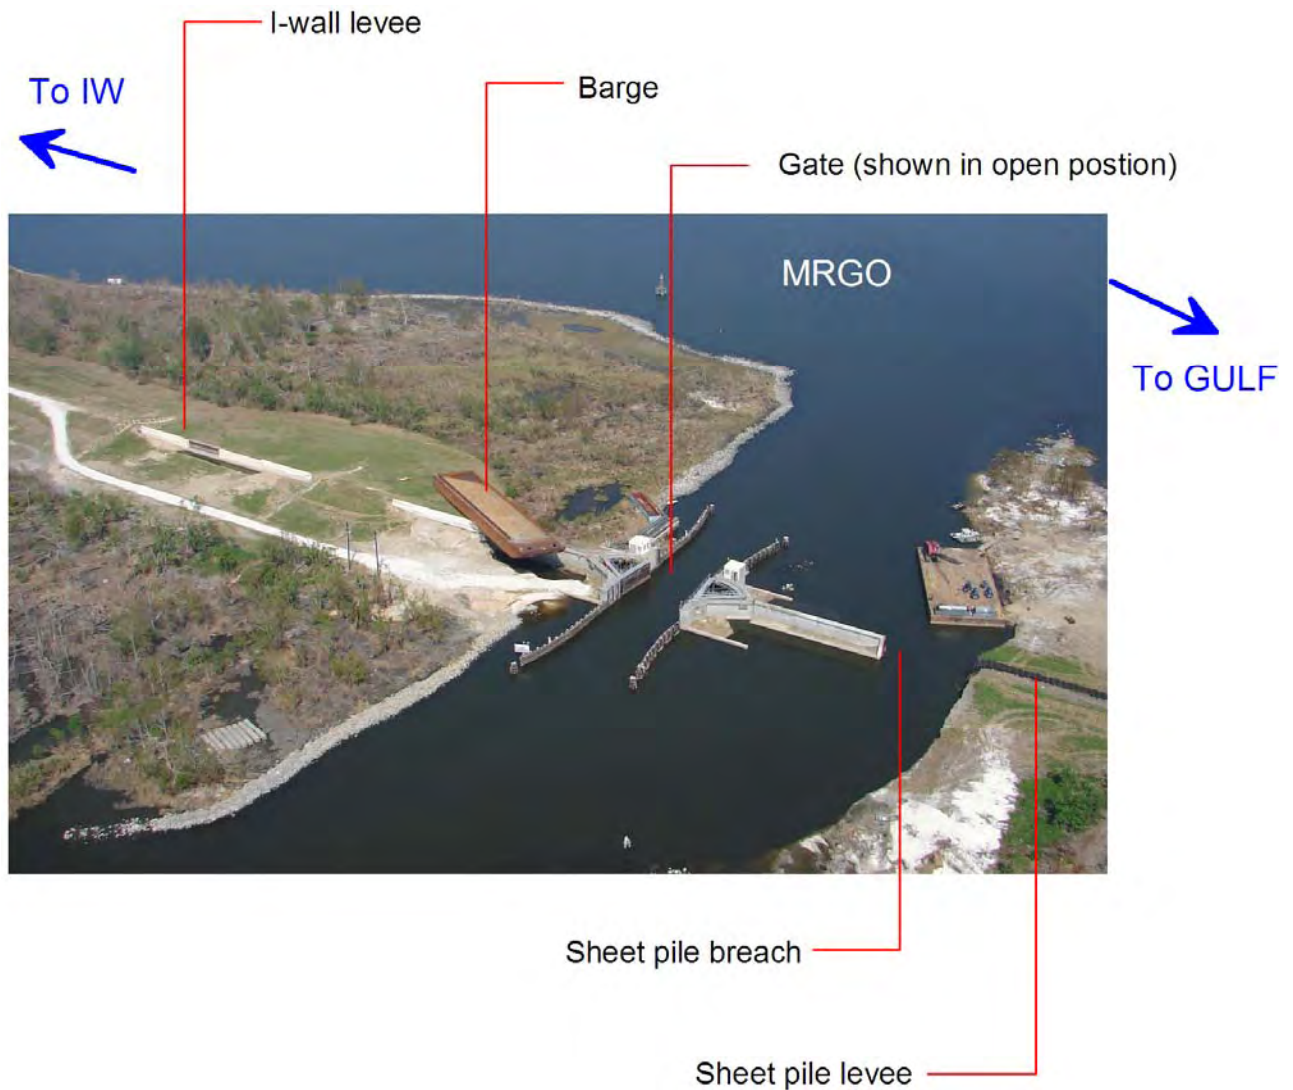
Figure 4.13 shows an approximately 80 ft. long levee breach in the sheet pile section located immediately east of the gate structure. The earthen portion of the levee was completely obliterated and the sheet pile wall appears to have been "torn" from its connection to the concrete gate structure, and overturned. Orleans Levee District staff indicated that the gates were closed during Hurricane Katrina, and later reopened (manually, due to the lack of electric power) after the storm had passed. Many of the sheet pile breach features were obscured by water at the site, and hence it was not apparent if the breach occurred due to a structural failure at the sheet pile gate connection, a result of overtopping, leading to scour and subsequent loss of passive resistance, or some combination of these factors. At the time of the last visit to the site on October 5, no repairs had been made to the breach.

Fig. 4.13: Sheet pile breach at the Bayou Bienvenue Gate (J. Wartman, October 5, 2005).

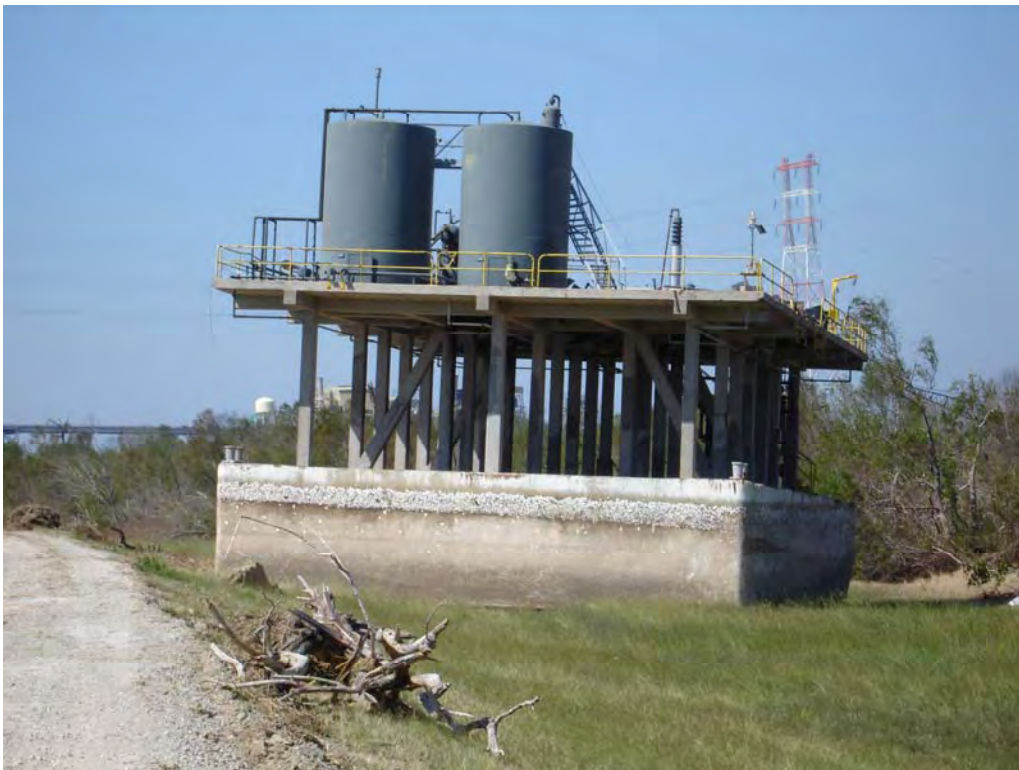
Fig. 18: Various barges and other floating structures made contact with the earth levees without causing significant damage. Photo shows a gas processing barge. (F. Silva, October 1, 2005).

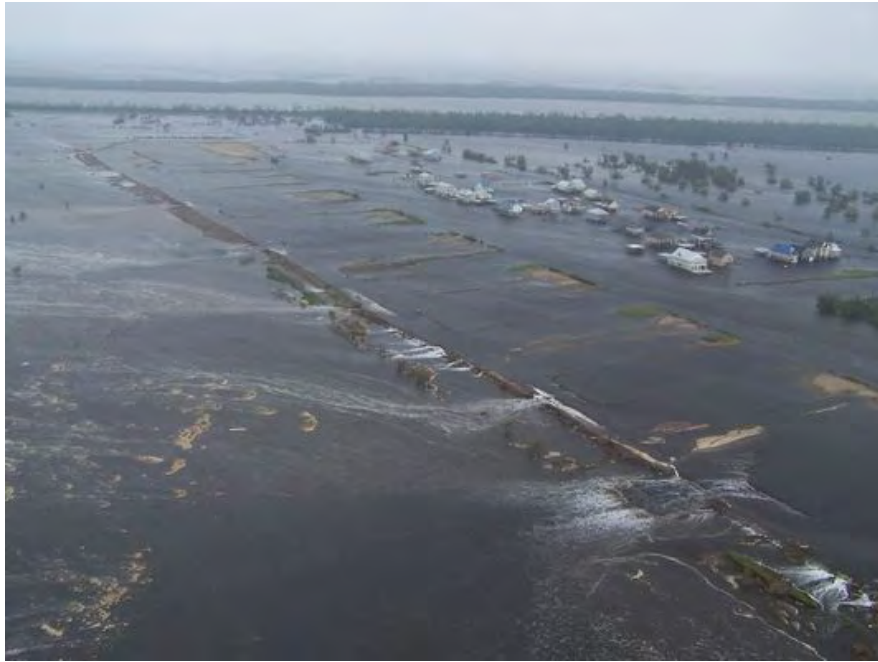
Sunrise - 29 21.62 N 89 33.67 W

Figure 5.2: Aerial photograph of levee breach of hurricane (back) levee along western side of the Mississippi River near the community of Sunrise (September 25, 2005)

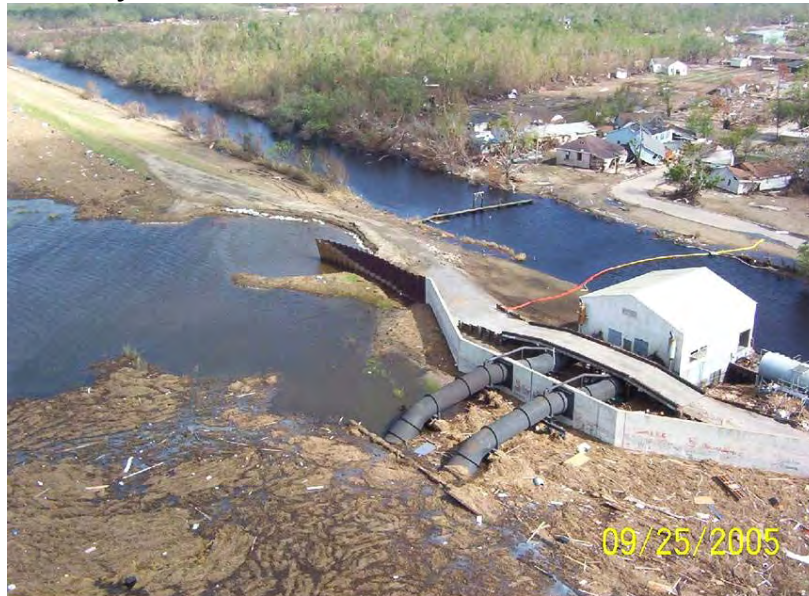
East Pointe a la Hache - 29 35.68 N 89 48.75 W

Figure 5.4: Aerial photograph of levee breach of hurricane (back) levee east of Pointe a la Hache (September 25, 2005)

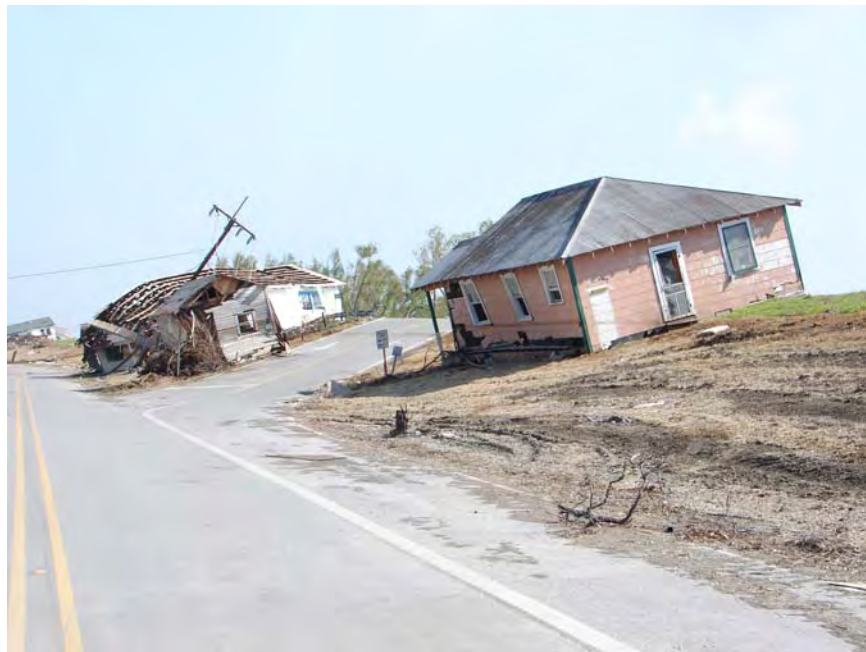
Figure 5.7: Photograph of Pointe a la Hache home deposited on Mississippi River levee crown after storm surges overtopped this levee from the east (left) towards the River – which is to the right in this photograph (October 12, 2005)

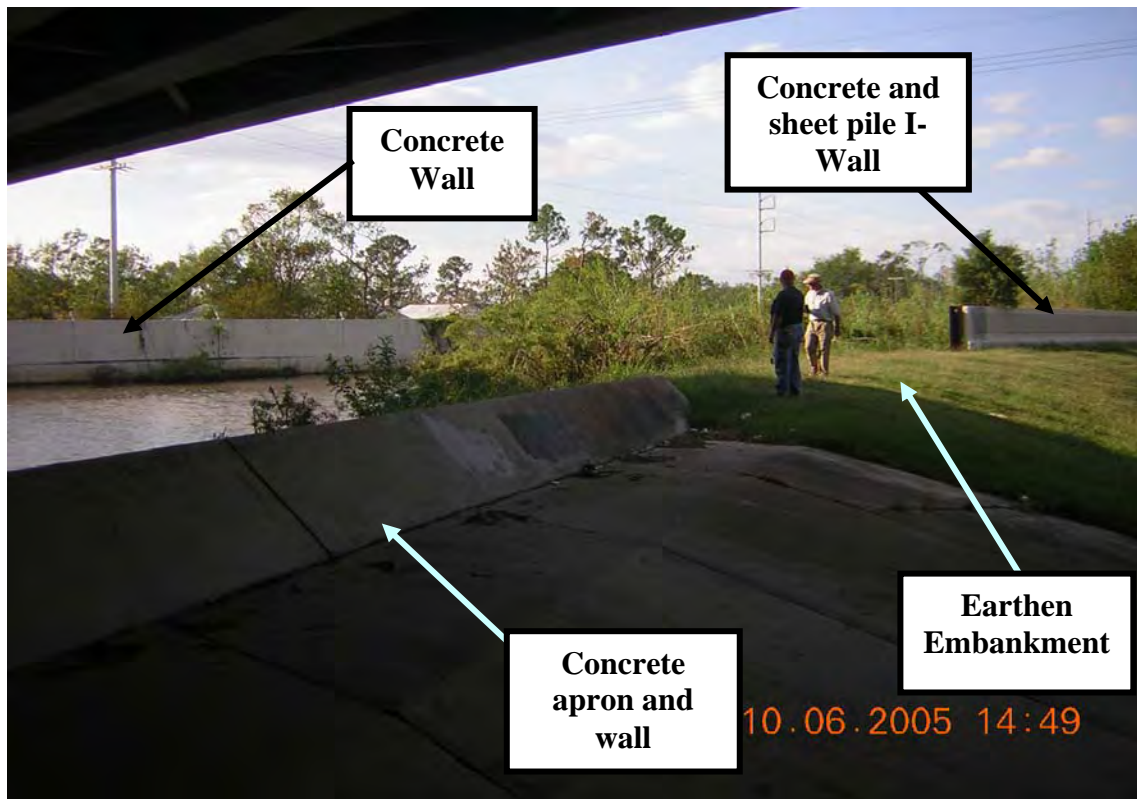
After touring the pump station, we surveyed the area immediately outside of the pump station to determine how the flood walls and other parts of the levee system had performed. We found that it had performed very well, with little signs of overtopping. However, as we toured the area we found that there were 5 different elevations of different parts of the levee system (Figure 6.9). For example, the flood walls abutted to adjacent earth levees that were substantially lower than the tops of the flood walls. Other variations in the elevations of the flood defense elements were correlated with the agencies that had responsibilities for various parts of this part of the system, (e.g.: highway department determining the heights under the road overpass immediately adjacent and upstream of the pump station, Figure 6.10)).

Figure 6.10: At the Orleans Canal pump station, the flood protection system consisted of different components, each with a different “top of wall” elevation.

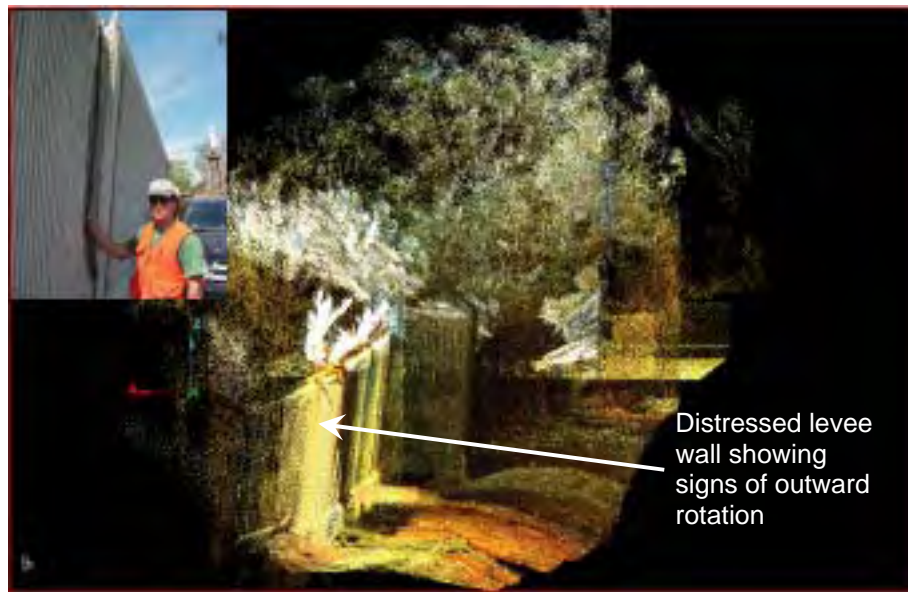
Laser mapping allows for highly accurate computation of rotation, length, area, and volume. Rotational displacement was common at areas of levee T-wall distress. For example, the east side of the London Canal immediately south of Robert E. Lee Boulevard suffered distress and lateral deformation associated with incipient failure of the levee. This movement is along a section of wall diagonally northeast of the west side breach across the canal. In Figure 7.13, an oblique image of the distressed wall can be seen from the southwest. The wall, preserved in incipient failure, leans toward the levee maintenance road and downstream portion of the levee. In the background is the abutment of the Robert E. Lee Bridge (to the right).

Figure 7.13: Leaning T-wall of a distressed portion of the London Canal. The wall leans toward the levee maintenance road and landslide portion of the levee. In the right-most background is the abutment of the Robert E. Lee Bridge along with vegetation on the canal side of the levee.

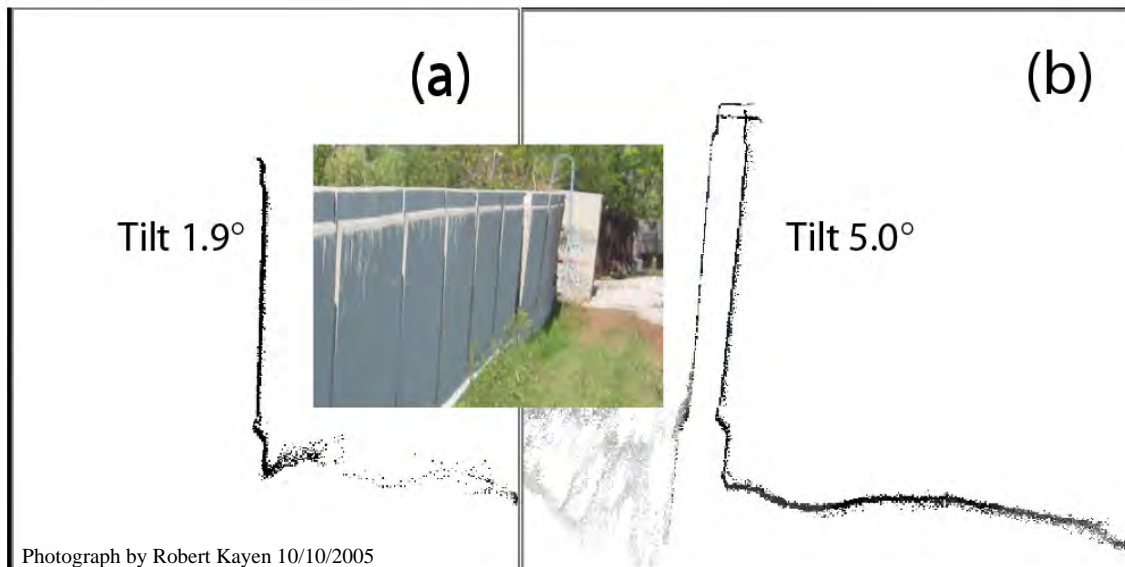
Considerable vegetation grows along the banks of the canal side of the levee that are less maintained for growth than the landside neighborhood-side of the levee wall. Thin slices of the point-cloud data orthogonal to the alignment of the levee wall (Figure 7.14) display highly accurate cross sections of the distressed T-wall at London Canal. Segment (a) is toward the south (left) of Figure 7.13 and has a modest 1.9 degree rotational deformation. Near a position of maximum distress, the T-wall has 5.0 degrees of rotational deformation toward the landside of the levee.

Figure 7.14: Cross sections through two segments of distressed T-wall at London Canal. Segment (a) is toward the south (left) of Figure 7.13 and has a modest 1.9 degree rotational deformation toward the downstream side of the levee. Near a position of maximum distress, the T-wall has 5.0 degrees of rotational deformation.

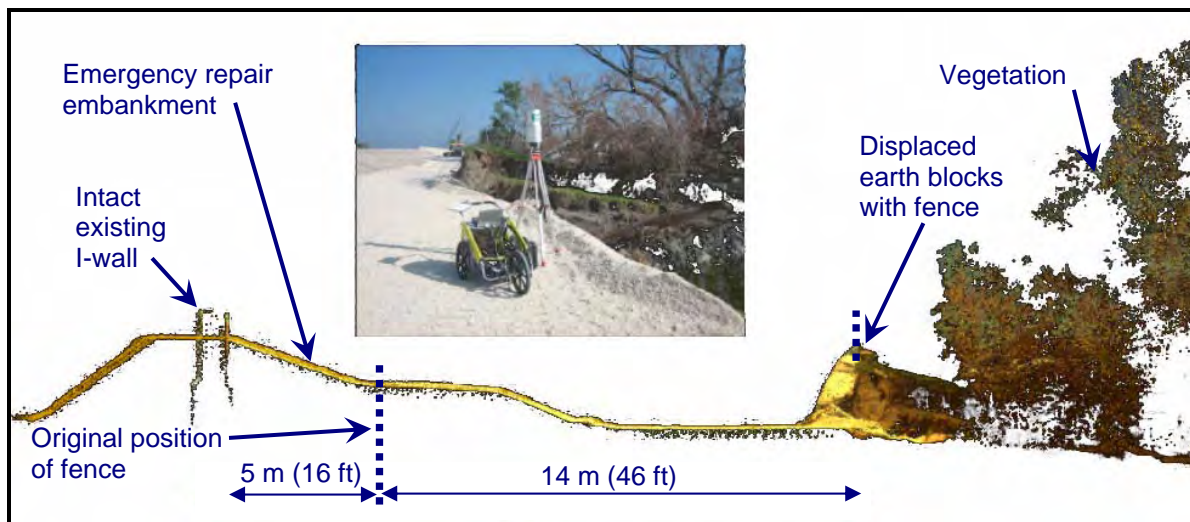
From the perspective shown in Figure 7.17, it can also be seen that the canal width of the 17th St. Canal has been shortened about 6 meters (20 ft) by the placement of the earthen embankment.

Figure 7.17: Measurement of the lateral translation of the downstream soil levee from its original position is approximately 14 meters (46 ft). The I-wall in this image is offset (out of the page) from the slide block.

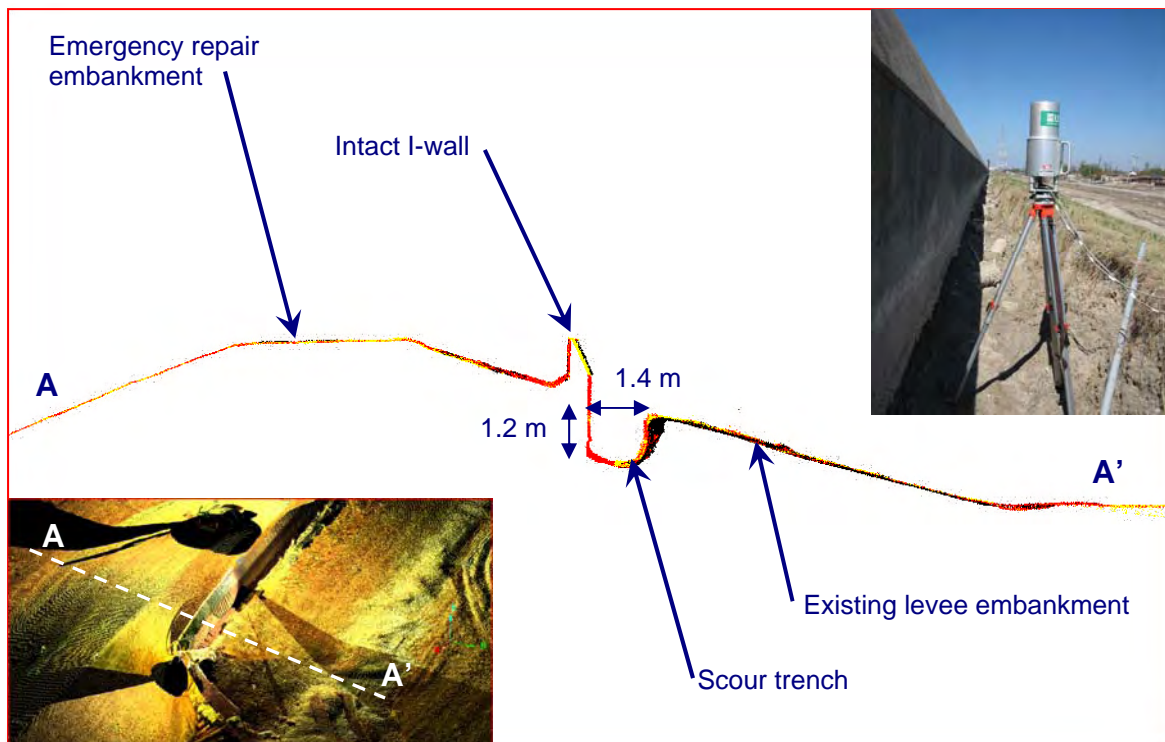
A final example of the use of the LIDAR data is shown in Figure 7.18. Here, the dimensions of the scour trench in the vicinity of the east side IHNC – south breach are outlined. This view shows the depth of the scour below the I-wall and into the embankment supported sheet pile so that a direct comparison of the scour depth to sheet pile embedment can be calculated.

Figure 7.18: Measurement of scour trench dimensions at the IHNC – South site.
